Errata Sheet V1.0

This Errata Sheet refers to:

**AT91
ARM® Thumb®
Microcontrollers**

**AT91M63200
AT91M43300
Errata Sheet
V1.0**

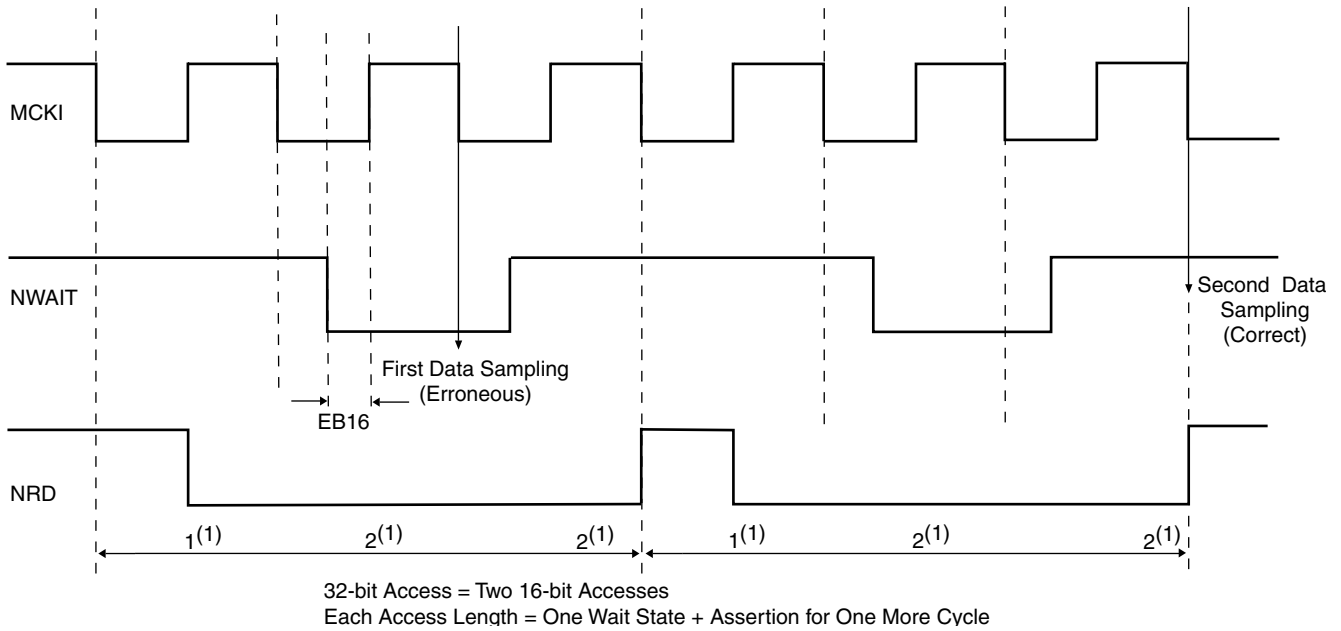
Figure 3. Number of Standard Wait States is One

If the first two conditions are not met during a 32-bit read access, the first 16-bit data is read at the end of the standard 16-bit read access. In the following example, the number of standard waits is one. NWAIT assertions do affect both NRD pulse lengths, but first data sampling is not delayed. The second data sampling is correct.

At maximum speed, asserting the NWAIT in the first access cycle is not possible, as the sum of the timings “MCKI Falling to Chip Select” and “NWAIT setup to MCKI rising” are generally higher than one half of a clock period. This leads to using at least one standard wait state. However, this is not sufficient except to perform byte or half-word read accesses. Word and write accesses require at least two standard wait states.

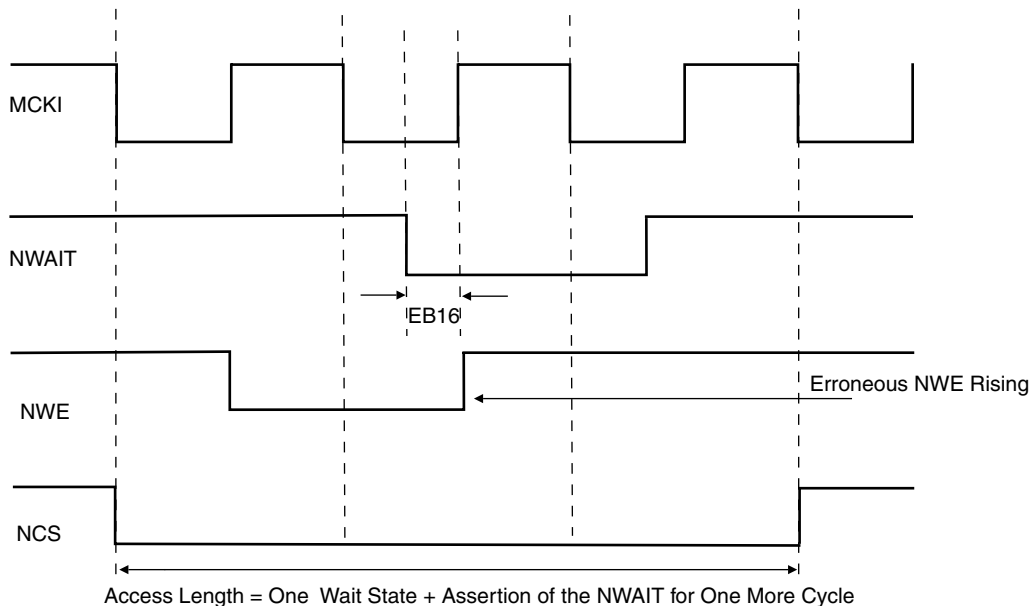
Figure 4. Description of the Number of Standard Wait States

If the first two conditions are not met during write accesses, the NWE signal is not affected by the NWAIT assertion. The following example illustrates the number of standard wait states. NWAIT is not asserted during the first cycle, but is asserted at the second and last cycle of the standard access. The access is correctly delayed as the NCS line rises accordingly to the NWAIT assertion. However, the NWE signal waveform is unchanged, and rises too early.
