PM7350

DSLAM WAN CARD REFERENCE DESIGN ERRATA

ISSUE 1: NOVEMBER 1999

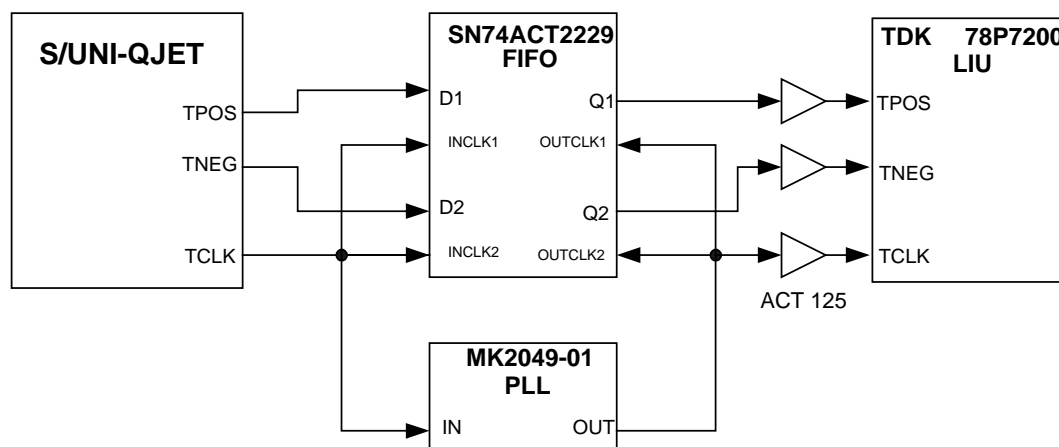
Problem: The DSLAM WAN Card had originally been designed with an added feature of meeting the specification for DS3 WAN jitter transfer. (Bellcore GR-499-CORE) This was to be accomplished using 4 FIFOs to synchronize upstream (destined for the WAN) data to a jitter-free clock, provided by 4 PLLs. (See figure 1). It has since been decided that this feature will be removed from the WAN Card due to complications in ensuring proper functionality of 4 PLLs in close proximity to each other.

Figure 1. Original jitter attenuation circuitry design. (Upstream data path for 1 out of 4 identical channels shown).

Fix: The 4 PLLs used to de-jitter 44.736 MHz clocks & the 4 FIFOs should be removed from the design. The TPOS, TNEG, and TCLK signals from the S/UNI-QJET should be connected directly to the ACT125 buffers leading to the TDC LIUs. (See Figure 2). All code within the FPGA dealing with FIFO control should be removed.

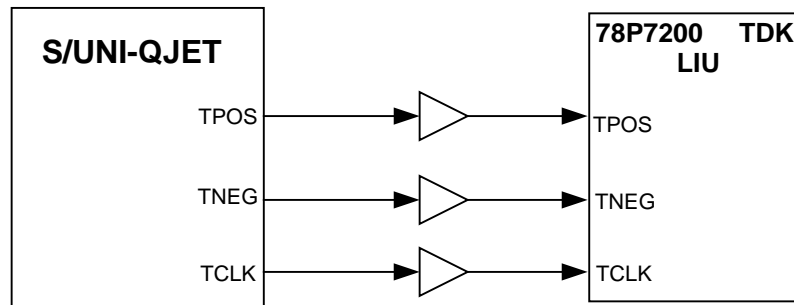
Figure 2. Revised design (no jitter attenuation circuitry).
