PM73488

QSE

DATA SHEET Errata

**Released
Issue 6: Feb. , 2002**

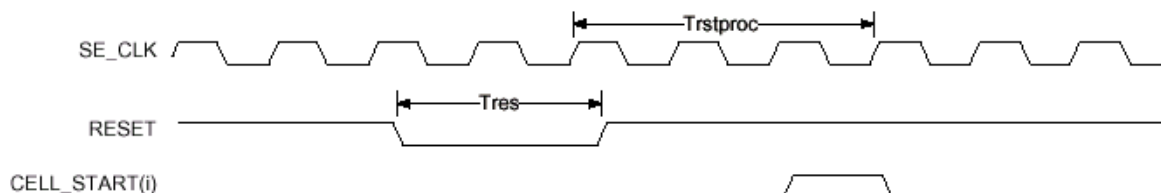
Figure 40 (Data sheet Issue 3). Reset Timing

The RESET signal shown in figure 40 of the data sheet (below) is defined as being asserted during the time period (Tres). Since the RESET pin on the QSE is defined as active high, the RESET signal in figure 40 is incorrect and should be inverted.
