Active Errata List

Radiation Tolerant FIFOs

M67206F M672061F M67204F Errata Sheet

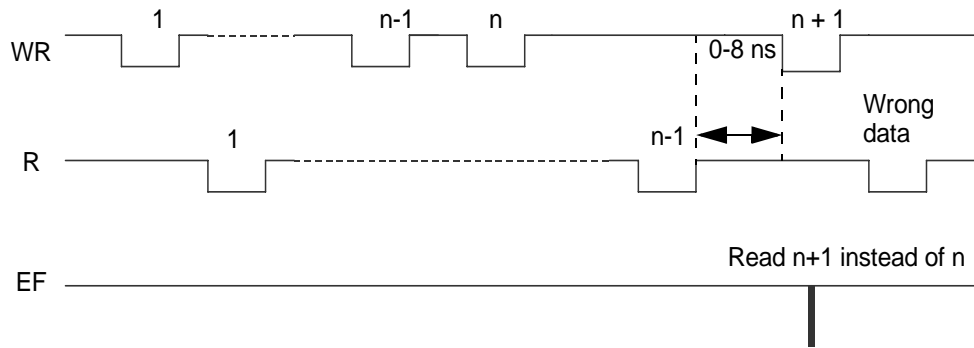
Figure 1. Behavior Description

Rising edge of READ from 0 ns up to 8 ns (typical) before the falling edge of WRITE when only one data is left to read.

See Figure 1 for behavior description.

Empty flag glitch and following data shift out 2nd byte corruption occurs when the rising edge of the first "READ" for data shift out occurs before falling edge of the third "WRITE" for data shift in.

between 0 ns and 11 ns

Temperature = 125°C

Voltage = 4.5V

These FIFOs are functional outside of the above timing and data marginal configuration.

The recommended action is to avoid this particular configuration.

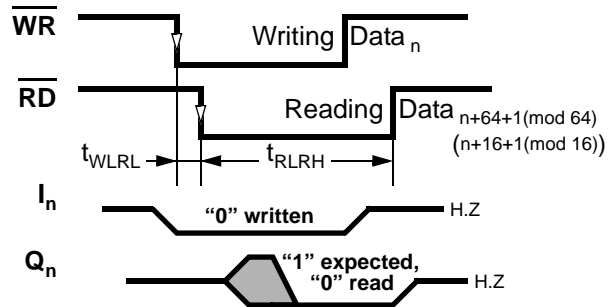
Sometimes a bit that has been written "1" is read "0".

1. Read and write commands fall down almost at the same time, t_{WLRL} parameter in the hereunder table.
2. Write bit "0" on input port while a bit "1" is expected on output port.
3. Reading the $64^{th}+1 \pmod{64}$ ($16^{th} + 1 \pmod{16}$) for 4Kx9 FIFO) vs. the writing location.
4. Read pulse (t_{RLRH}) less than the one specified in the hereunder table.

The memory array of the 16Kx9 FIFO contains 64 columns, the 4Kx9 contains 16 columns. To reduce the read access time, a pipe line has been implemented on the data path. When the data_n is going out of the FIFO, the data_{n+1} is pre-fetched for the next read access. When the internal writing and reading are different from $64 \pmod{64}$ ($16 \pmod{16}$), a write and a read access are made on the same column. Coupling between the read bit-line and the write bit-line only disturbs the pre-fetch operation, forcing the sense amplifier to output "0". Then, the next external reading may be wrong.

t_{WLRL}		t_{RLRH}
	minimum	maximum	
67206H / 672061H	≥ 0 ns	≤ 8 ns	≤ 30 ns
67204H	≥ -2 ns	≤ 8 ns	≤ 25 ns

1. No read sequence while write sequence.
2. Control the gap between the read and write locations
3. Control the t_{WLRH} parameter in accordance with the above table.
4. Apply a read pulse t_{RLRH} greater than the value given in the above table.

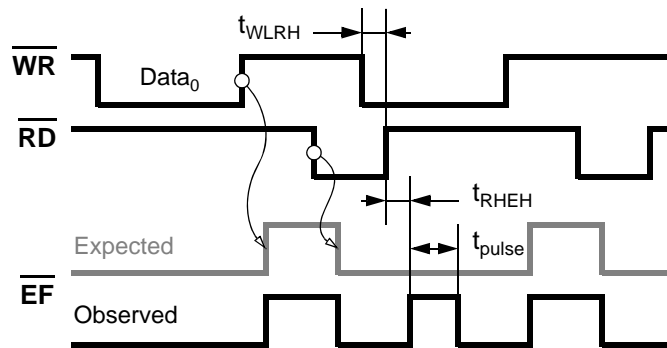
1. \overline{WR} wide pulse width:

A parasitic positive pulse can be observed during a FIFO write if it is applied during the read of first data of the FIFO buffer (c.f. hereunder chronograms).

Un-controlled delays on input signals of a flags logic decoder generate an internal glitch. This glitch is re-formatted by the on-chip ETD system (Edge Transition Detection) and a parasitic pulse is output on EF pin.

1. No write sequence while read sequence.
2. \overline{EF} evaluation according to the following characterization.

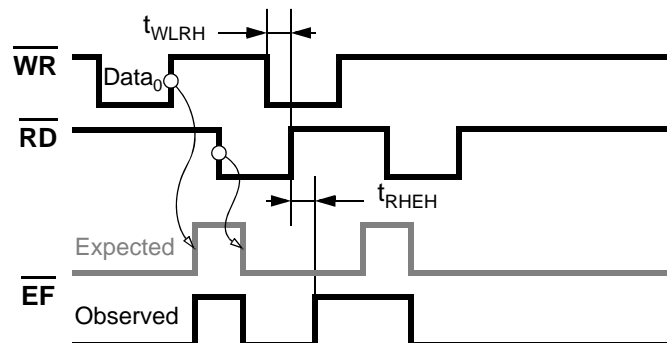
2. \overline{WR} short pulse width:

In this case, the falling edge of the parasitic pulse is masked by the beginning of the regular high level of \overline{EF} flag.
