CY7C129*DV18/CY7C130*DV25
CY7C130*BV18/CY7C130*BV25/CY7C132*BV25
CY7C131*BV18 / CY7C132*BV18/CY7C139*BV18
CY7C191*BV18/CY7C141*AV18 / CY7C142*AV18/
CY7C151*V18 /CY7C152*V18

Errata Revision: *C

May 02, 2007

RAM9 QDR-I/DDR-I/QDR-II/DDR- II Errata

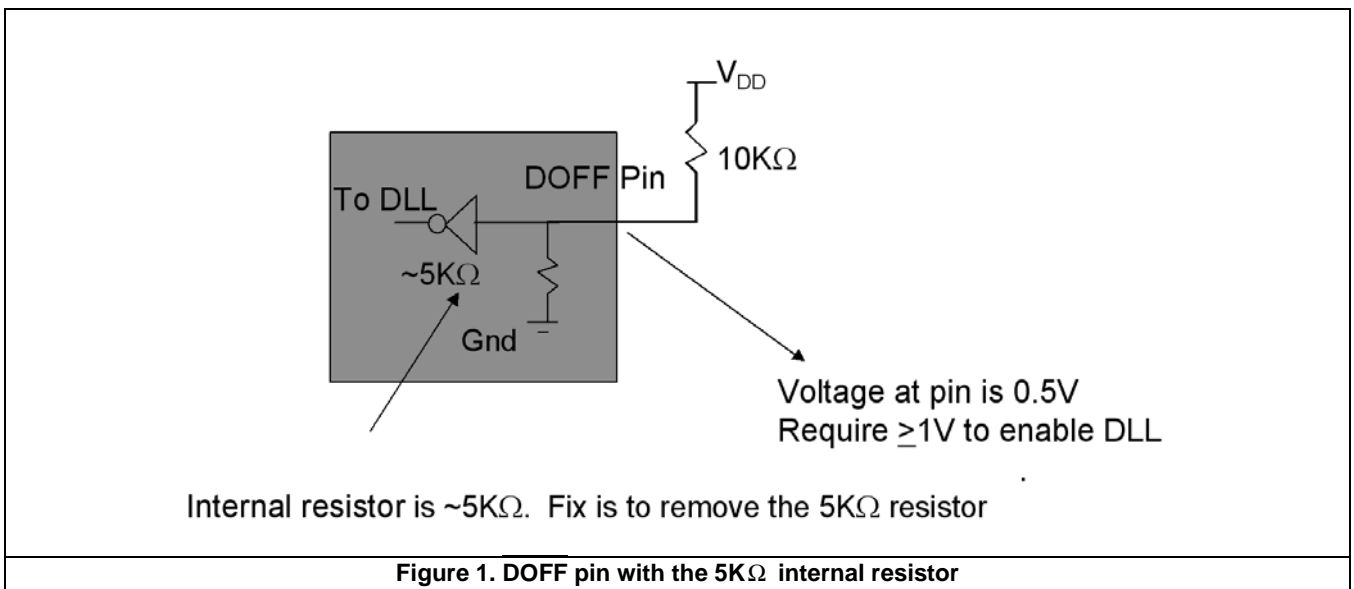
This issue involves the DLL not turning ON properly if a large resistor is used (eg:-10K Ω) as an external pullup resistor to enable the DLL. If a 10K Ω or higher pullup resistor is used externally, the voltage on DOFF is not high enough to enable the DLL.

Figure 1 shows the DOFF pin circuit with an internal 5K Ω internal resistor. The fix planned is to disable the internal 5K Ω leaker.

Fix involved removing the internal pull-down resistor on the $\overline{\text{DOFF}}$ pin. The fix has been implemented on the new revision and is now available. The new revision is an increment of the existing revision. The following table lists the devices affected, current revision and the new revision after the fix.

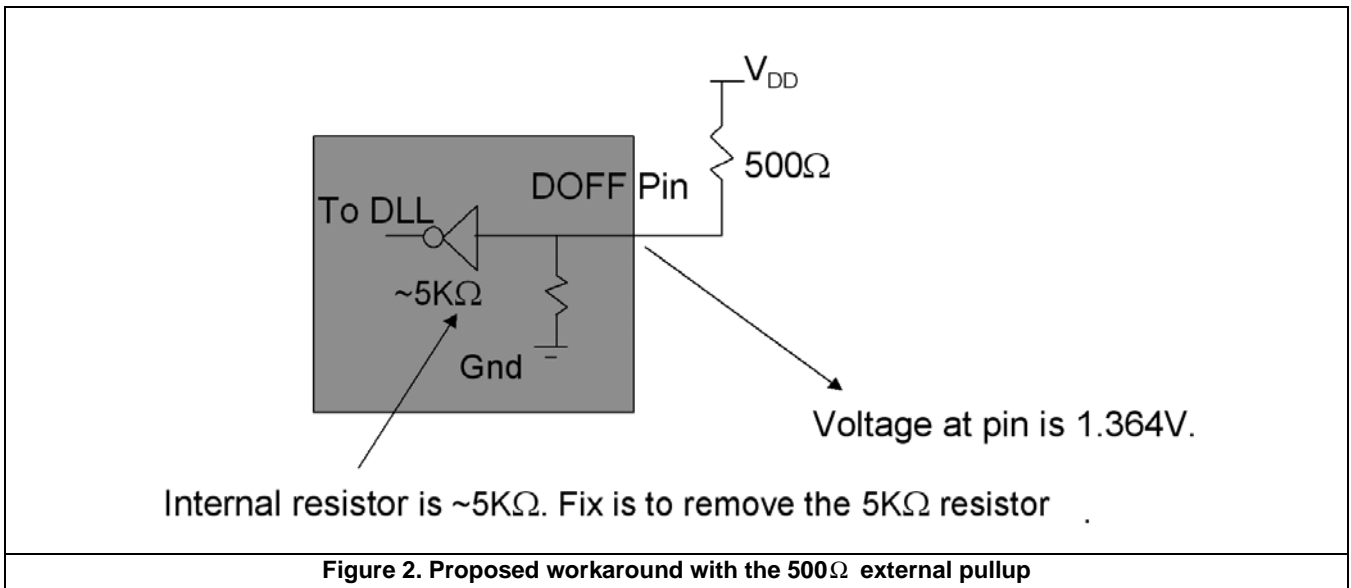
Figure 2 shows the proposed workaround and the fix planned.

The workaround is to have a low value of external pullup resistor for the $\overline{\text{DOFF}}$ pin (recommended value is $\leq 500\Omega$). When $\overline{\text{DOFF}}$ pins from multiple QDR devices are connected through the same pull-up resistors on the board, it is recommended that this $\overline{\text{DOFF}}$ pin be directly connected to VDD due to the lower effective resistance since the "leakers" are in parallel.

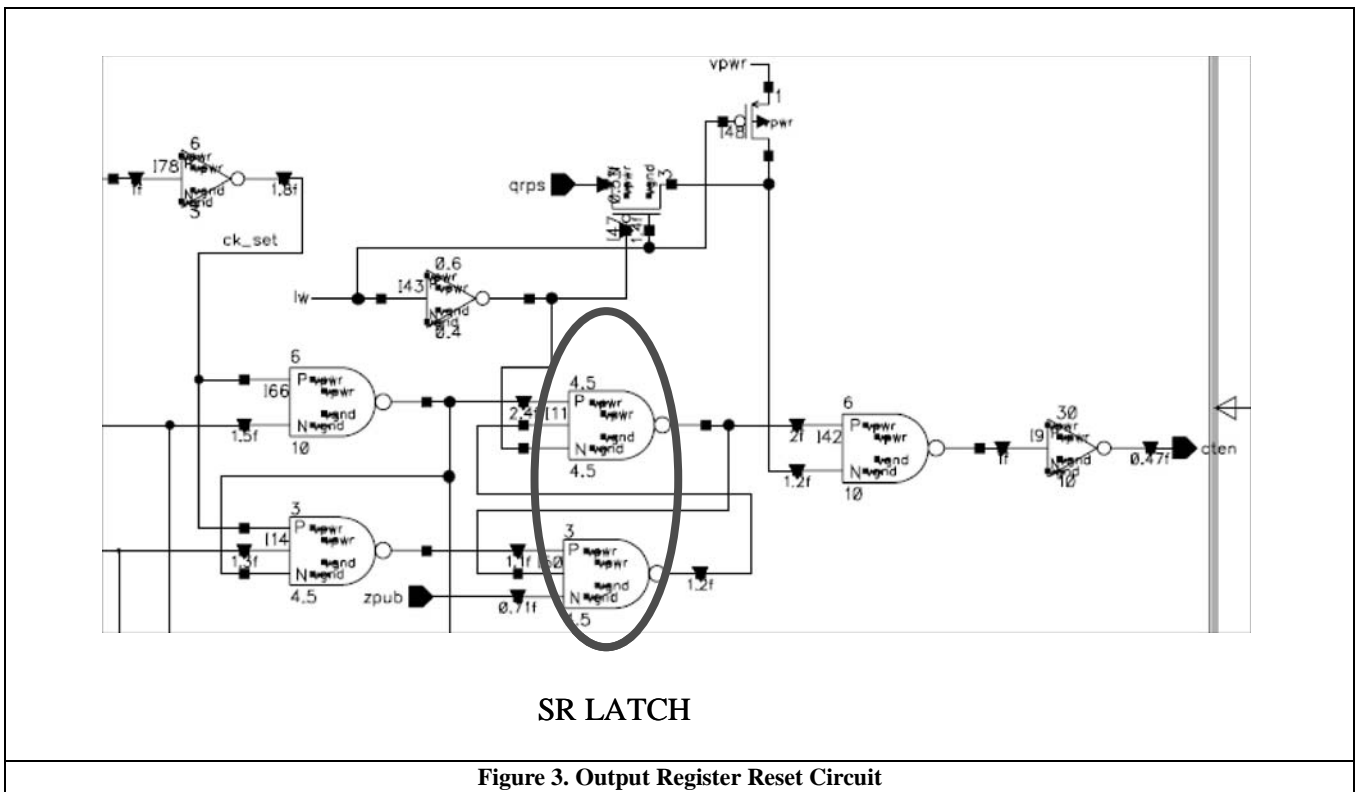
This issue involves the output buffer entering an unidentified state when the input signals (only Control signals or Clocks) are floating during reset or initialization of the memory controller after power up.

Figure 3 shows the output register Reset circuit with an SR Latch circled. This latch has two inputs with one of them coming from some logic affected by the clock and RPS#(QDR) or WE# and LD#(DDR). The issue happens when clocks are glitching/toggling with controls floating. This will cause the SR latch to be taken into an unidentified state. The SR Latch will need to be reset by a dummy read operation if this happens.
