PM7375

Revision F Device Errata

Issue 4: December, 1997

PMC-960529 (r4)

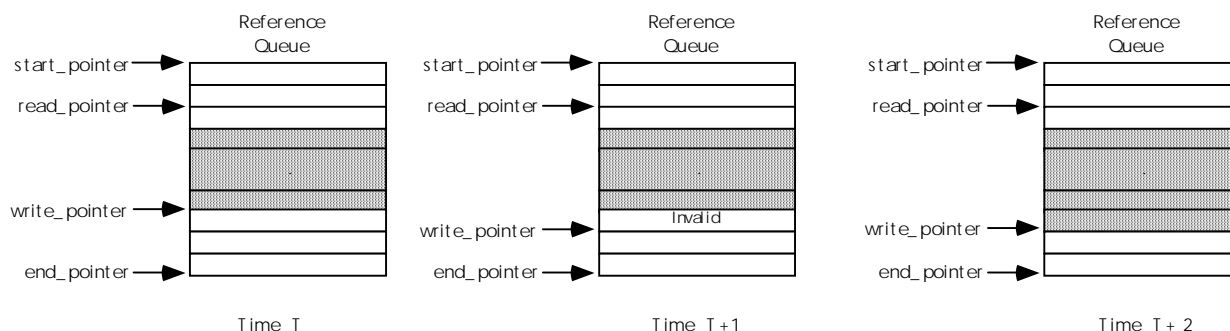
Figure 2.1: Queue Race Condition Example.

The race condition is that the write_pointer may be incremented before the element is fully written into the queue. When this occurs, the last queue element is invalid until the write operation is fully completed. This is illustrated in the example below:

- At "Time T", the LASAR-155 is ready to insert a new element into the Reference Queue.
- At "Time T+1", the write_pointer is increment before the new element is written into the queue. As a result, the position referenced by the write_pointer contains invalid data.
- At "Time T+2", the new element is added. Now the position referenced by the write_pointer contains valid data.

There is a possibility that the queue element may contain invalid data.

To ensure that only valid queue elements are read, the device driver first marks all queue elements as "unused". This is done when initializing the queues. When there is a notification that one or more elements are inserted into the queue, the device driver checks whether the queue element is "unused". If it is marked as "unused", the device driver will read the same position again until the new element is added. This is illustrated in the following example:

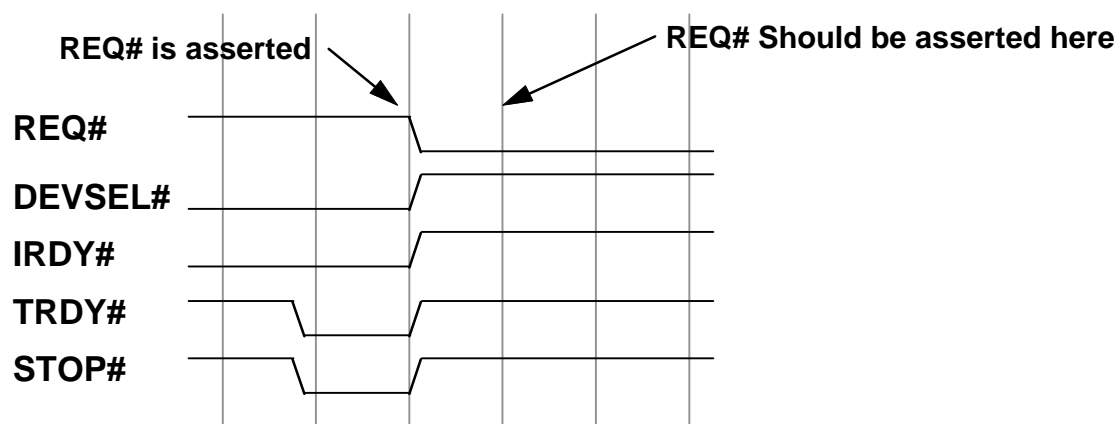
Figure 2.3 After a Target Disconnect the REQ# is asserted during Idle State.

After a target disconnect, the LASAR-155 does not deassert the REQ# for two clock cycles when it should. According to the PCI 2.1 specification, when the current data transaction is terminated by the target, either Retry or Disconnect, the master must deassert its REQ# for a minimum of two clock cycles. These two clock cycles are defined as follows: the first clock cycle being when the bus transitions to the Idle state (at the end of the transaction where STOP# is asserted) and the second either one clock cycle before or one clock cycle after the Idle state. The LASAR-155 correctly deasserts REQ# for one clock cycle before the Idle state and then incorrectly reasserts the REQ# during the Idle state.

There is a possibility that the LASAR-155 would unfairly request access to the bus.

The impact of this problem depends on the arbitration scheme used. This problem should not affect normal operation of the PCI bus.

Typical arbitration schemes use a combination of agent priority and round robin access. The LASAR-155 will request the bus one clock cycle earlier than it should. However, other agents will still have access to the bus via the round robin arbitration.
