TMPR3927 Specification Update

TMPR3927F, TMPR3927AF, TMPR3927BF, TMPR3927CF

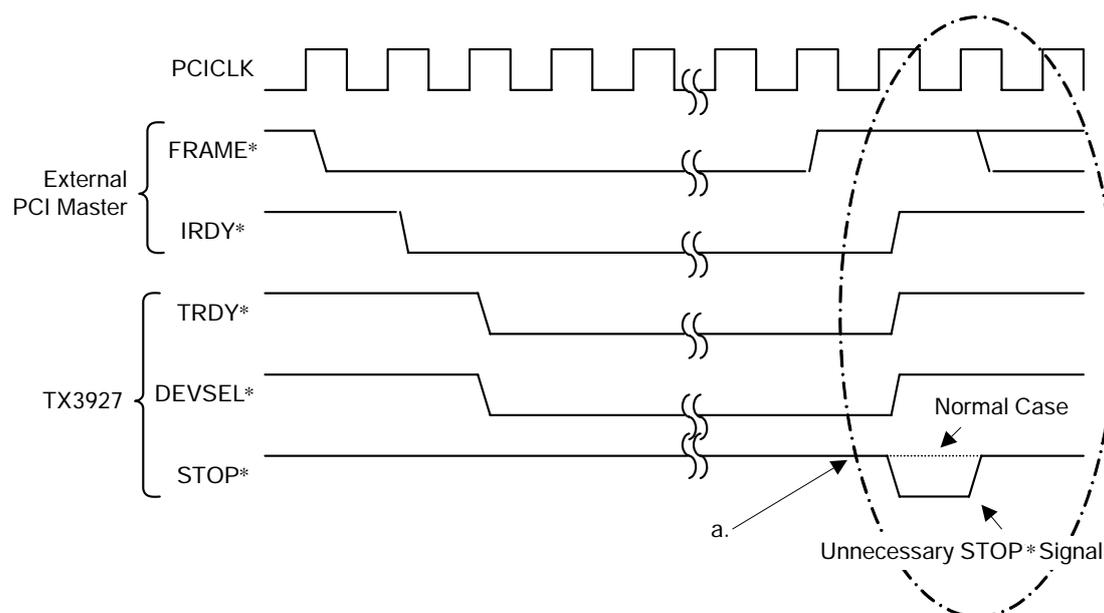
Figure 1 Unnecessary assertion of the STOP* signal

As shown in Figure 1 below, the PCI Controller in the TX3927 may, under particular conditions, assert the STOP* signal unnecessarily exactly when the PCI bus is idle. The external PCI master may be affected by this STOP* signal.

When the TX3927 PCI Controller is operating in Target mode and an external PCI master is bursting to the TX3927, the TX3927 PCI Controller asserts the STOP* signal unnecessarily when the completion of the burst cycle (a in the above figure) coincides with particular conditions of the TX3927.

- 1) When all of the following conditions a) to c) are true:
 - a) Bit 3, or the OFIFO 8-Clock Rule Enable (OF8E) bit, in the Target Control (TC) register (at 0xFFFFE_D090) of the PCI Controller is cleared.
 - b) The current burst cycle is a read.
 - c) The OFIFO becomes empty immediately before point a. in the above figure.

- 2) When all of the following conditions a) to c) are true:
 - a) Bit 4, or the IFIFO 8-Clock Rule Enable (IF8E) bit, in the Target Control (TC) register of the PCI Controller is cleared.
 - b) The current burst cycle is a write.
 - c) The IFIFO becomes full immediately before point a. in the above figure.

- 3) When all of the following conditions a) to c) are true:
 - a) Bit 11, or the PCI Snoop (PSBP) bit, in the Chip Configuration (CCFG) register at 0xFFFFE_E000 is cleared.
 - b) The current burst cycle is a write.
 - c) The CPU core requests bus mastership at point a. in the above figure while another bus master on an internal bus is executing a bus cycle.

- 1) When the burst cycle is a read
Set the OF8E bit in the Target Control (TC) register of the PCI Controller.

- 2) When the burst cycle is a write
 - a) Set the IF8E bit in the Target Control (TC) register of the PCI Controller.
 - b) Set the PSNP bit in the Chip Configuration (CCFG) register. In this case, however, it is prohibited to use the data cache in Write-back mode.

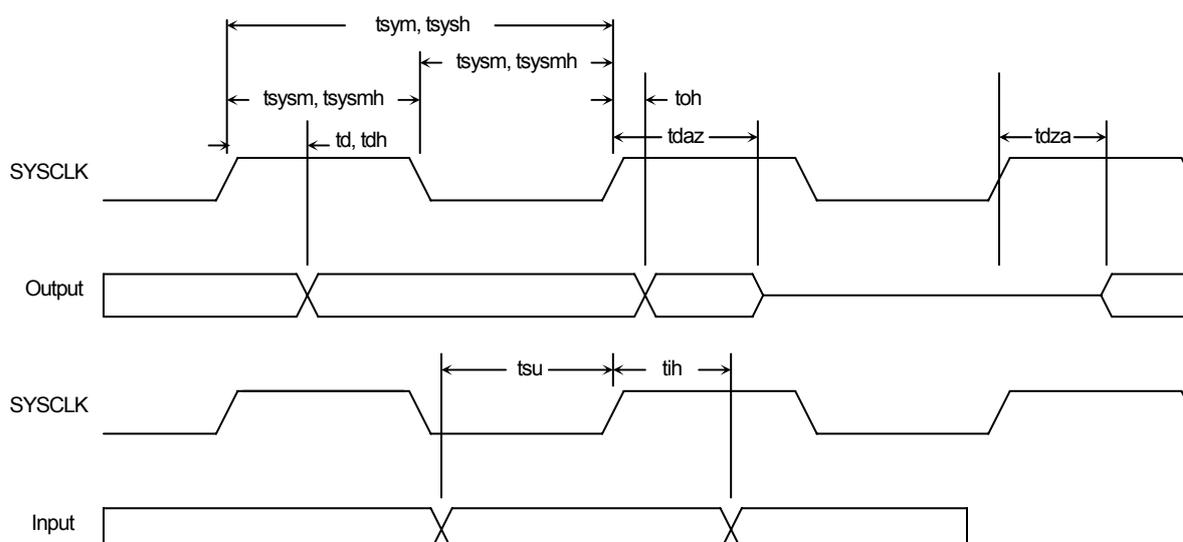
Timing Diagram (SDRAMC and ROMC Signals)

Under particular conditions, the assertions of ADDR, ACE*, CE*, OE* and BE* are delayed by $t_{\text{sysh}}/2$ (i.e., a half of the reference clock for Half-Speed mode) when the TX3927 ROM Controller accesses the area mapped to a Half-Speed channel.

Under these conditions, ADDR, ACE*, CE*, OE* and BE* are delayed by $t_{\text{sysH}}/2$ (i.e., a half of the reference clock for Half-Speed mode). Since these signals are deasserted as usual, their active periods become $t_{\text{sysH}}/2$ shorter than the usual.

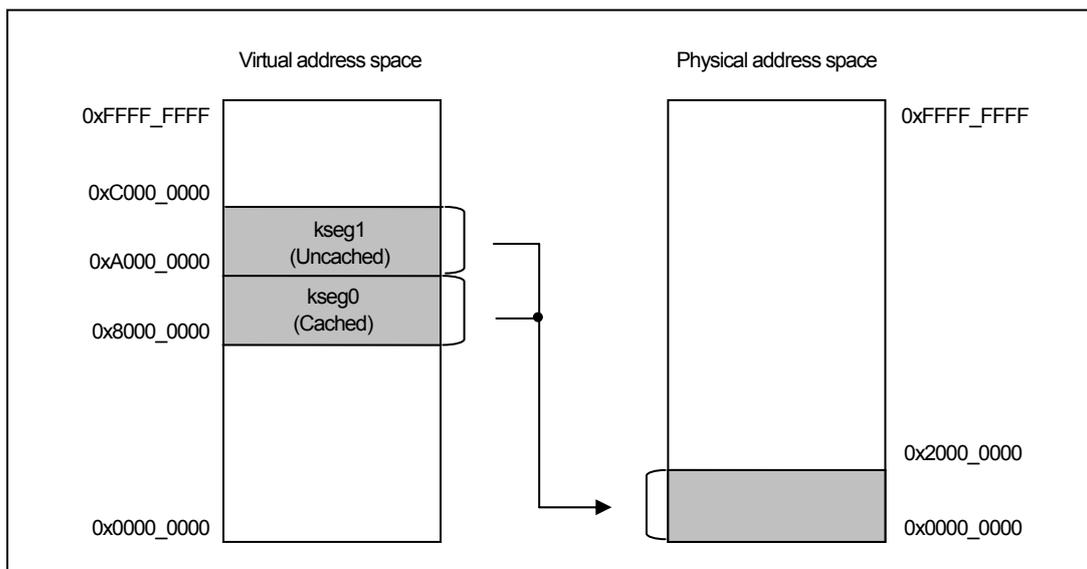
Consequently, reading data from a cached area and writing that data to an uncached area whose physical address is the same as the read address has an effect equivalent to flushing the data cache with the CACHE instruction.

For example, if the data address that is the target of cache flushing is 0x8000_0000, perform the following steps:

- 1) Read out data from 0x8000_0000.
Because 0x8000_0000–0x9FFF_FFFF is a cached area, a read request is first issued to the data cache. Thus, when address 0x8000_0000 hits in the data cache, data is read from it. In the case of a cache miss, data is read from main memory (physical address 0x0000_0000).
- 2) Write the data that was read in step 1) to 0xA000_0000.
Because 0xA000_0000–0xBFFF_FFFF is an uncached area, data is always written to main memory (physical address 0x0000_0000).
- 3) Invalidate the data cache line containing data whose address is the same as that of step 1). This can be done with the CACHE instruction with the op field (bits 20:16) of 0x11.

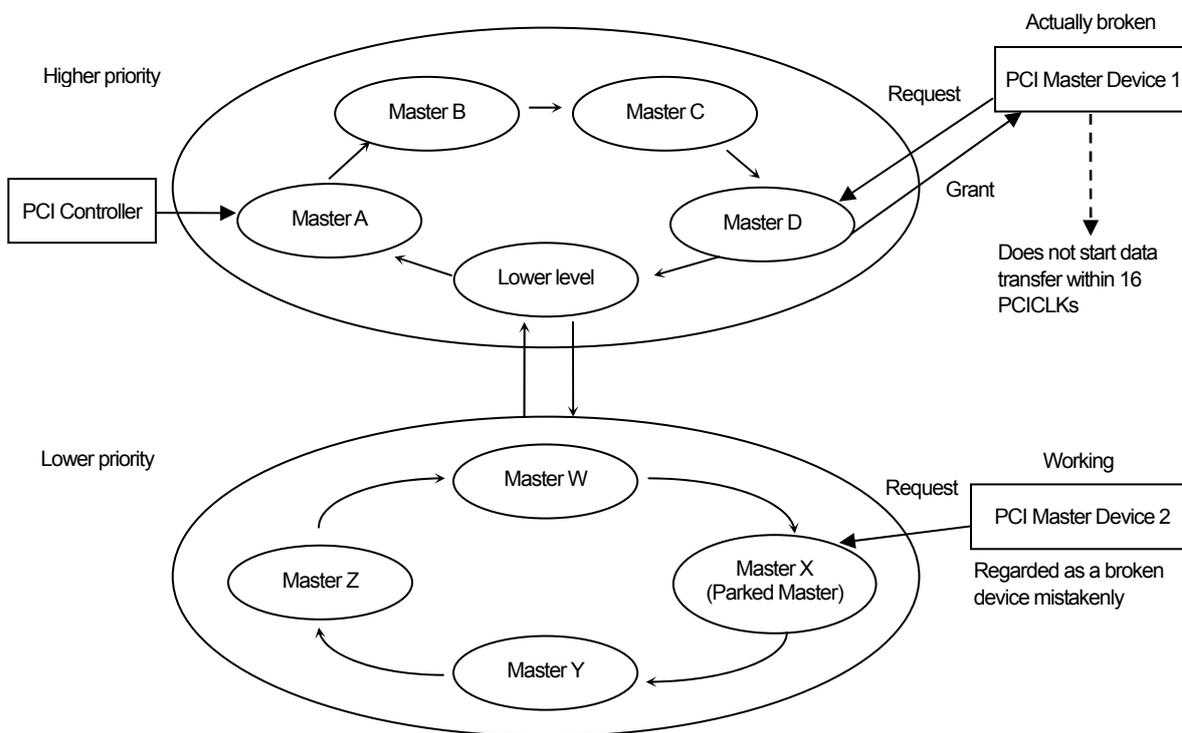
PCI Bus Arbitration Priority (an example when a problem occurred)

If you enable the PCI broken master checking feature, a working master device may be regarded as a broken master device and detached from the PCI bus arbiter.

- (1) The Broken Master Check Enable bit is set (BMCEN=1).
This bit is bit 0 of the PCI Bus Arbiter/Parked Master Control Register (PBAPMC). The default is 0.
- (2) There are two PCI bus arbiter groups: higher-priority group and lower-priority group (see the following figure). The assignment of PCI bus masters to the bus arbiters is specified in the Request Trace Register (REQ_TRACE).
- (3) When a master device in the higher-priority group is detected as broken, a master device in the lower-priority group activates a PCI bus request and is given the highest priority in that group. Among the lower-priority group, master W has the highest priority upon reset. Afterwards, a master which got the PCI bus last has the highest priority. (A master with the highest priority is called a parked master.)

If all the above conditions become true simultaneously, this problem occurs and the parked master device is detached from the PCI bus arbiter.

- 1) Disable the broken master checking feature by clearing the BMCEN bit of the PBAPMC register to 0.
- 2) If you need to use the broken master checking feature, then only use the higher-level arbiter (masters A, B, C and D).
