PM7375

Revision F Device Errata

Issue 4: December, 1997

PMC-960529 (r4)

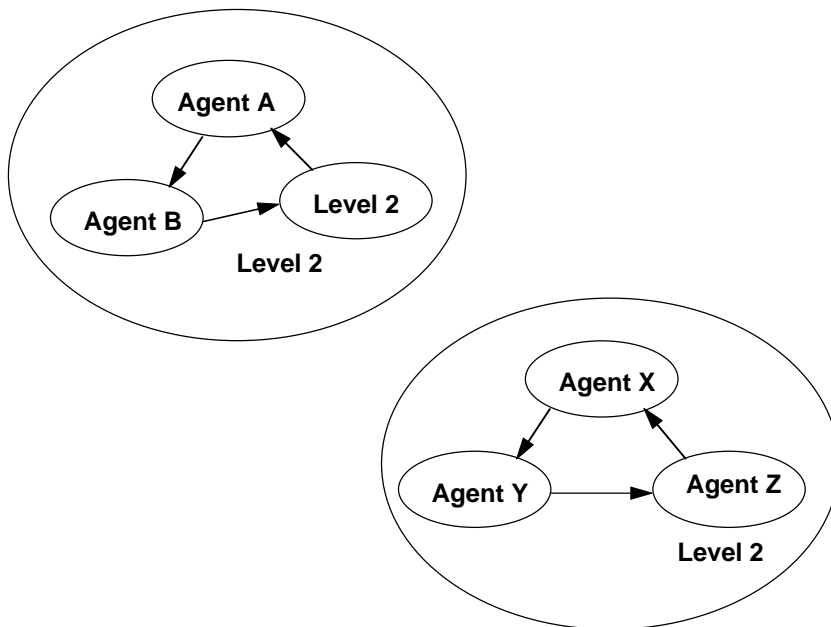
Figure 2.4 Typical PCI Bus Arbitration using a "Fairness Algorithm"

A typical arbitration example that implements a fairness algorithm is found in the PCI Local Bus Specification 2.1. This example assumes a two level bus architecture with the higher priority agents attached to level 1 (low latency or greater bandwidth).

Second level agents have equal access to the bus with respect to other second level agents. However, second level agents, as a group, have equal access to the bus as level one agents as shown in the following example:
