PM7385
FREEDM-84A672
REVISION B DEVICE ERRATA

ISSUE 2

FEBRUARY, 2000

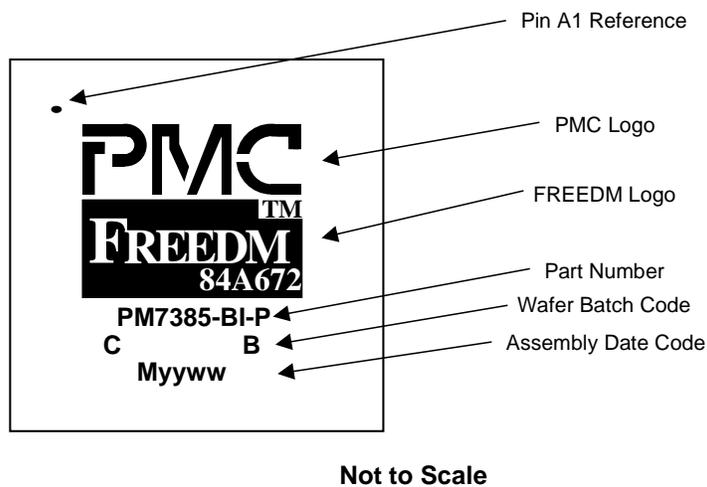
Figure 1.1: PM7385 FREEDM-84A672 Branding Format.

The information contained in Section 2 relates to Revision B of PM7385 FREEDM-84A672 only. The device revision code is marked at the end of the Wafer Batch Code on the face of the device (as shown in Figure 1.1). PM7385 FREEDM-84A672 Revision B is packaged in a 352-pin Ball Grid Array (SBGA).
