**PM7384**  
**FREEDM-84P672**  
**REVISION B DEVICE ERRATA**

**Issue 2**

**March 2000**

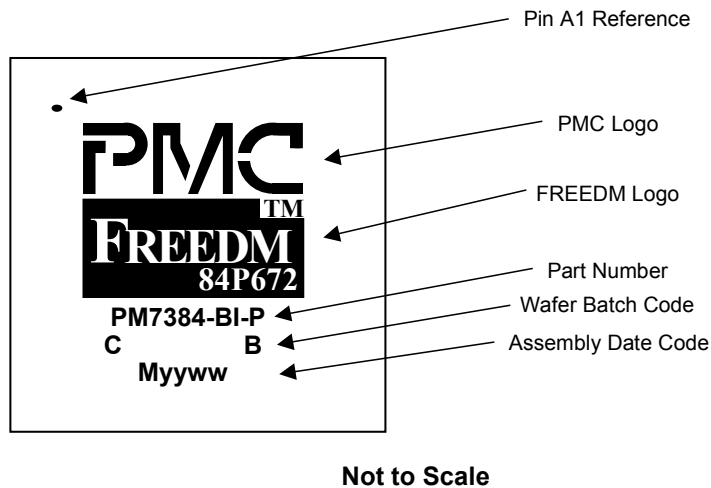
**Figure 1.1: PM7384 FREEDM-84P672 Branding Format.**

The information contained in Section 2 relates to Revision B of PM7384 FREEDM-84P672 only. The device revision code is marked at the end of the Wafer Batch Code on the face of the device (as shown in Figure 1.1). PM7384 FREEDM-84P672 Revision B is packaged in a 352-pin Ball Grid Array (SBGA).
