PM7384
FREEDM-84P672
REVISION C DEVICE ERRATA

Issue 5

December 2001

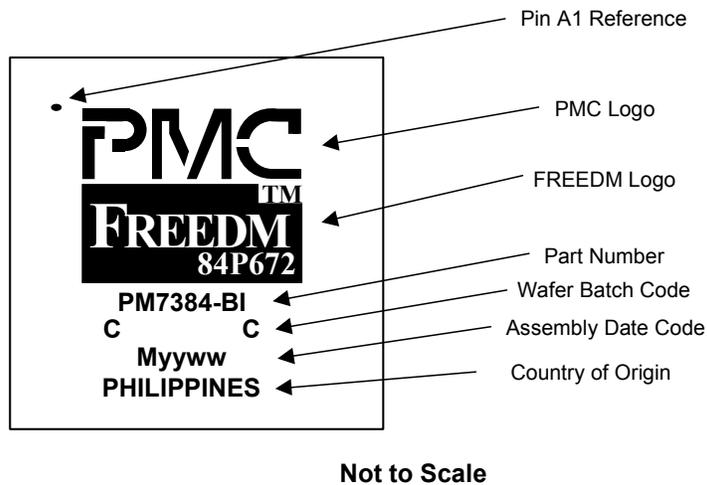
Figure 1.1: PM7384 FREEDM-84P672 Branding Format.

The information contained in Section 2 relates to Revision C of PM7384 FREEDM-84P672 only. The device revision code is marked at the end of the Wafer Batch Code on the face of the device (as shown in Figure 1.1). PM7384 FREEDM-84P672 Revision C is packaged in a 352-pin Ball Grid Array (SBGA).
